Fire Risk Assessment

Structured per PAS 79-1:2020

Mill House

8 Old Mill Lane, Leeds, LS10 1RT

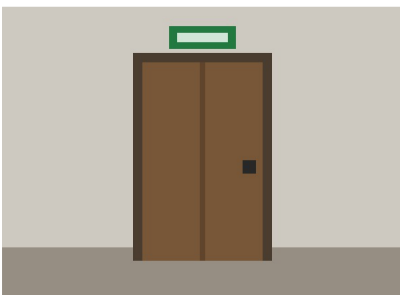
Sample evidence — protected escape route, fire door with intumescent strip

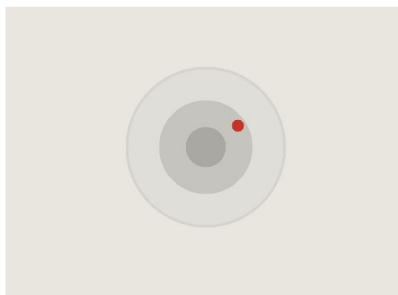
Sample evidence — ceiling-mounted detector, common area
